## Test Report

### Report no. 23-210-03740-PB

high-pressure flushing test acc. to DIN 19523:2008-08, Method 1 (material test)

| Sample designation: | SUBOR GRP pipe |

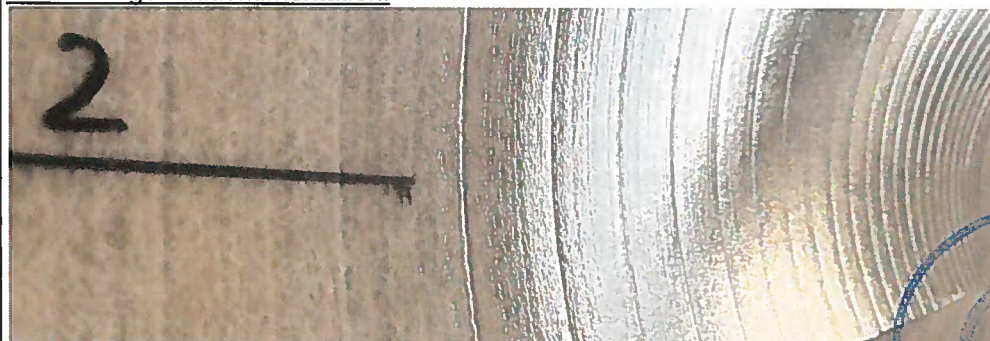
Bemerkung / Bilddokumentation:

**Prüfparameter vor Prüfung Strecke 2**

| Spülstrahlleistungsdichte [W/mm²] : | | | <b>452,8</b> |

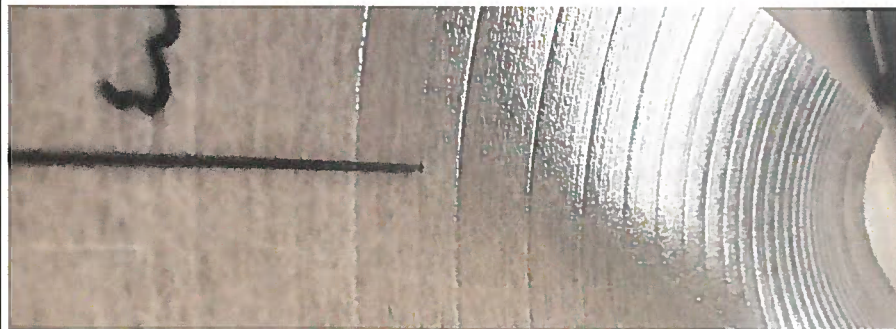
Bemerkung / Bilddokumentation:

**Prüfparameter vor Prüfung Strecke 3**

| | | <b>Spülstrahlleistungsdichte [W/mm²] :</b> | <b>456,0</b> |
